# AIRCRAFT COMMERCE

**THRUST REVERSER  
REPAIR MANAGEMENT  
REMOVAL CAUSES, SHOP VISIT  
PROCESSES & COSTS EXPLORED**

# Thrust reverser repair process & economics

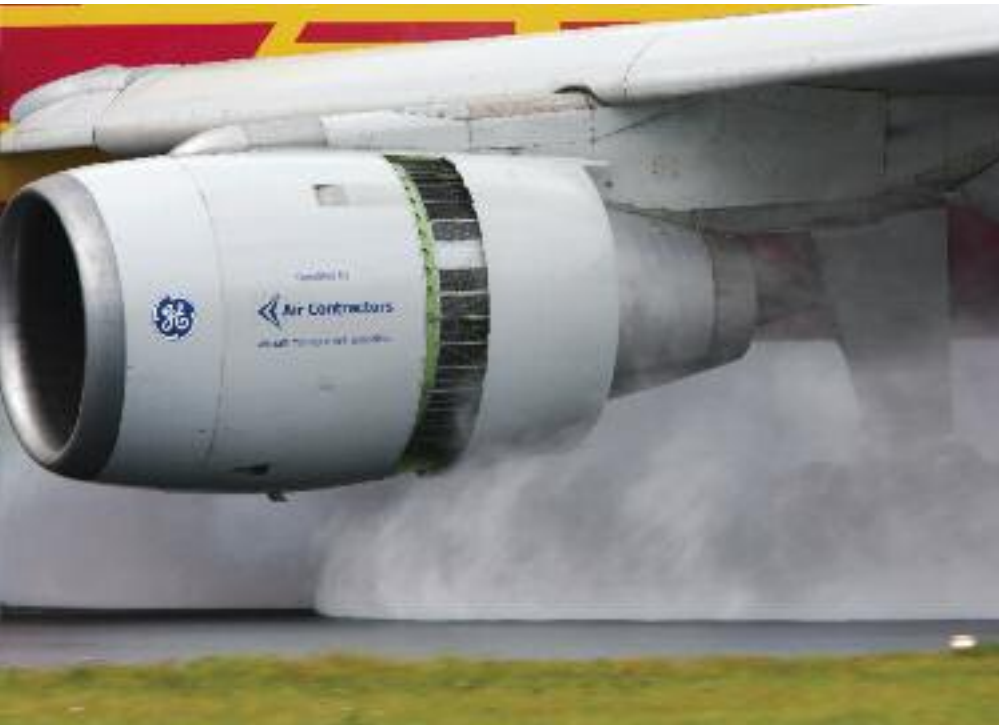
*The majority of in-service and in-production thrust reversers are the sliding sleeve type. The aft section of the engine cowl sliding rearwards exposes cascades, or grilles, through which bypassed air is forced to pass through by the closing of blocker doors in the bypass duct.*

"The sliding sleeve type of thrust reverser achieves reverse thrust by the outer wall of the third rear section of the engine cowling sliding backwards," explains Dr Christian Sauer, manager of engineering and planning, aircraft-related components at Lufthansa Technik. This sliding action exposes cascades, or grilles, in the walls of the cowling. In reverse mode, blocker doors are moved from a stowed position to block the path of the bypassed air through the duct. This forces the air to pass out through the cascades. "The bypassed air has to turn through more than 90 degrees, and exit through the side of the engine cowling," adds Sauer.

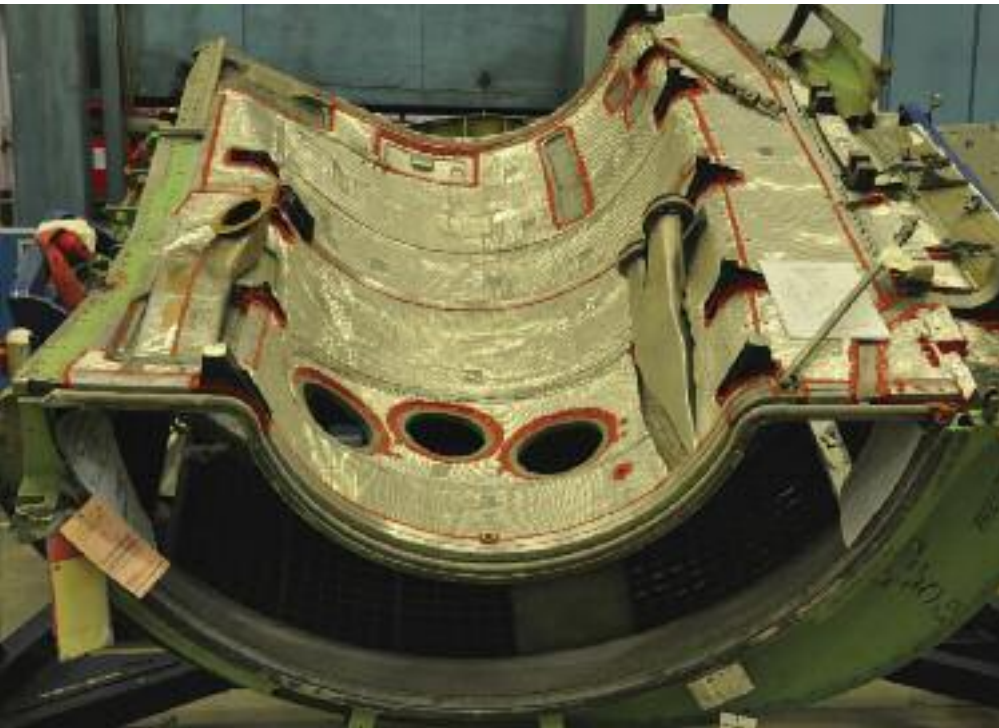
*One of the major issues of thrust reverser repair is delamination of composite material that is bonded to metal structure. This is caused by moisture freezing at altitude, causing disbonding. The degree of delamination increases exponentially with time on-wing.*

There are several main types of deterioration. “A main problem is delamination between the various layers of the main structure, blocker door deterioration and delamination, and sliding sleeve cowl,” says Thibaut Campion, head of sales component services at Sabena Technics. “This happens on all structures that use composite materials. Delamination occurs where honeycomb is bonded to a metal structure. Humidity gets between the composite and metal, and freezes when the aircraft is operating at altitude. The ice then expands. This process is repeated every time the aircraft flies, and eventually causes the separation between the composite and the metal. Corrosion is another significant problem. The degree of delamination and corrosion is therefore exacerbated by a harsh operating environment.”

“Delamination makes the repairs of the main C-duct sleeves expensive,” says Aykut. “It involves a full disassembly and NDT inspection, and requires a large backplate tool to maintain the shape of
